Joel Stoltzfus<sup>1</sup>

## Fires in P-3 Aircraft Oxygen Systems

**ABSTRACT:** Fires in three P-3 aircraft oxygen systems have occurred: one in the Royal Australian Air Force (RAAF) in 1984 and two in the U.S. Navy in 1998 and 2003. All three fires started in the aluminum manifold and check valve (MCV) assembly and produced similar damages to the aircraft in which they occurred. This paper discusses a failure analysis conducted by the NASA Johnson Space Center White Sands Test Facility (WSTF) Oxygen Hazards and Testing Team on the 2003 U.S. Navy VP-62 fire. It was surmised that the fire started due to heat generated by an oxygen leak past a silicone check valve seal or possibly because of particle impact near the seat of one of the MCV assembly check valves. An additional analysis of fires in several check valve poppet seals from other aircraft is discussed. These burned poppet seals came from P-3 oxygen systems that had been serviced at the Naval Air Station (NAS) in Jacksonville following standard fill procedures. It was concluded that these seal fires occurred due to the heat from compression heating, particle impact, or the heat generated by an oxygen leak past the silicone

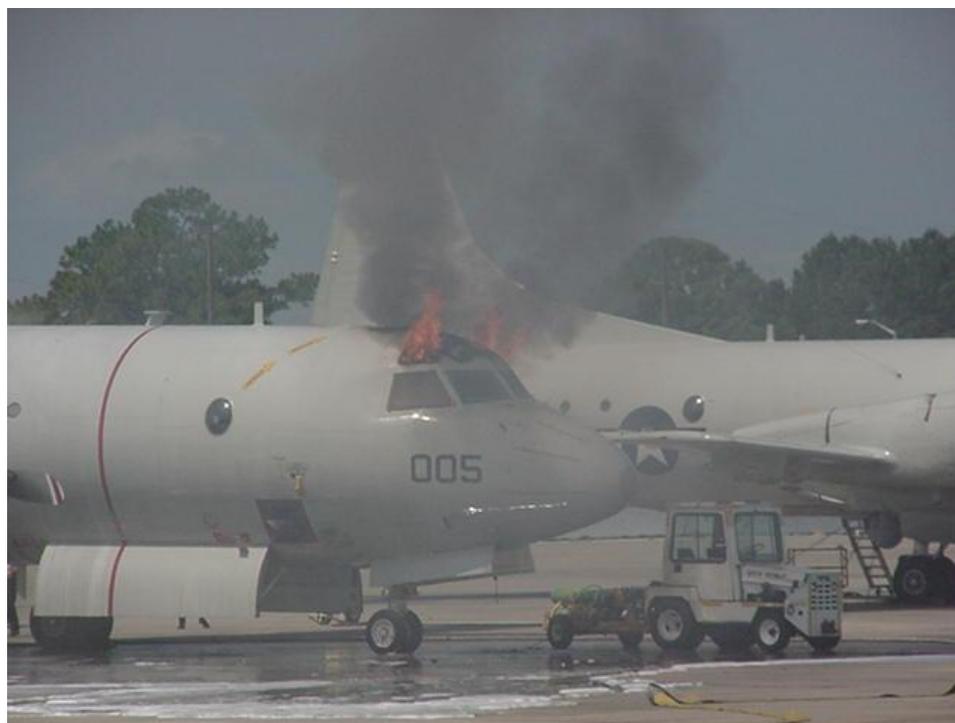
NAS Jacksonville, Florida

The fire damages to the aircraft are shown in Figures 4 through 7. Fig. 4 shows the burning aircraft, and Fig. 5 shows the exterior damages to the aircraft. It is apparent the damage is centered in the location of the flight station oxygen system. Fig. 6 shows the damaged oxygen system looking inboard through the burned holes in the aircraft skin. Fig. 7 shows the damaged MCV assembly. The body of the inlet manifold in the vicinity of check valves 2 and 3 is burned through from the inside-out. The poppet or check valve 3 is missing. The burn patterns in the aircraft indicate this is the location of the first burn-through and provide strong evidence this manifold is the location of the initial fire.

FIG. 4—Fire in P-C3 aircraft at NAS Jacksonville.

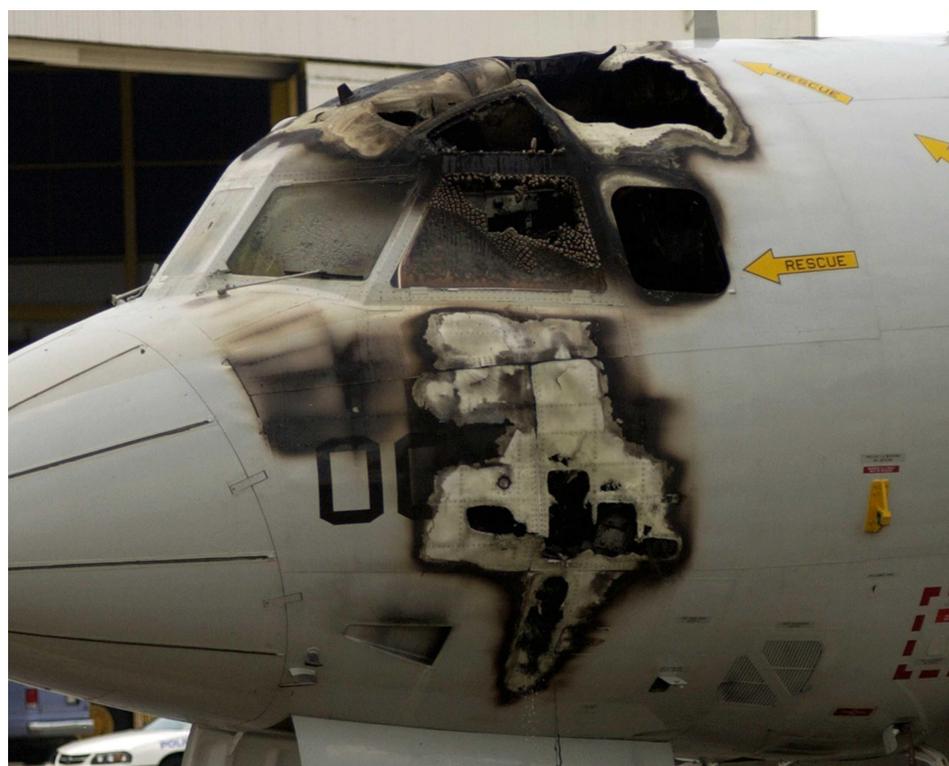
NAS Jacksonville, Florida

FIG. 5—Exterior damages caused by flight station oxygen system fire.

As noted previously, the damages to the aircraft were centered in the location of the flight station oxygen system [Fig. 5] and the MCV assembly was the central location from which the fire emanated. A large portion of the MCV assembly was burned away [Fig. 7] and the component appeared to have burned from the inside out. The oxygen fill valve was intact, as were the overboard discharge indicator, the pressure reducer assembly, the oxygen cylinder and valve assembly, the diluter demand oxygen regulators, and the smoke mask assemblies. The damages to the tubing in the vicinity of the MCV assembly could be easily explained as collateral damages occurring after the fire burned through the MCV assembly wall. Therefore, the MCV assembly was postulated as being the origin of the fire.

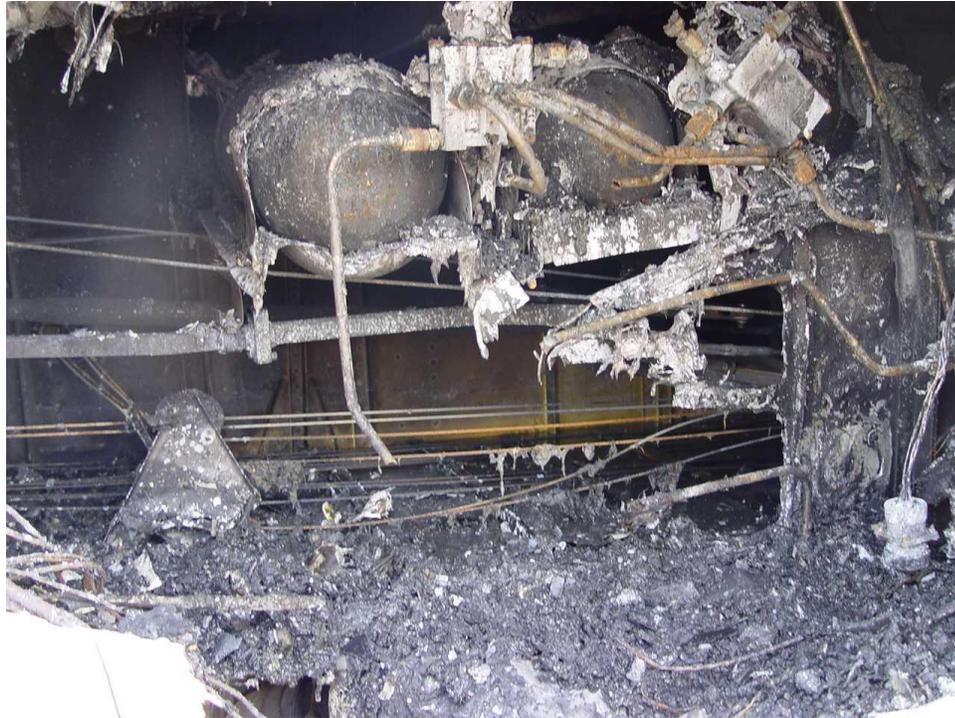
NAS Jacksonville, Florida

*FIG. 6—Damages to flight station oxygen system components looking inboard through the holes (some of the damaged aircraft skin have been removed) in the aircraft exterior shown in Fig. 2.*

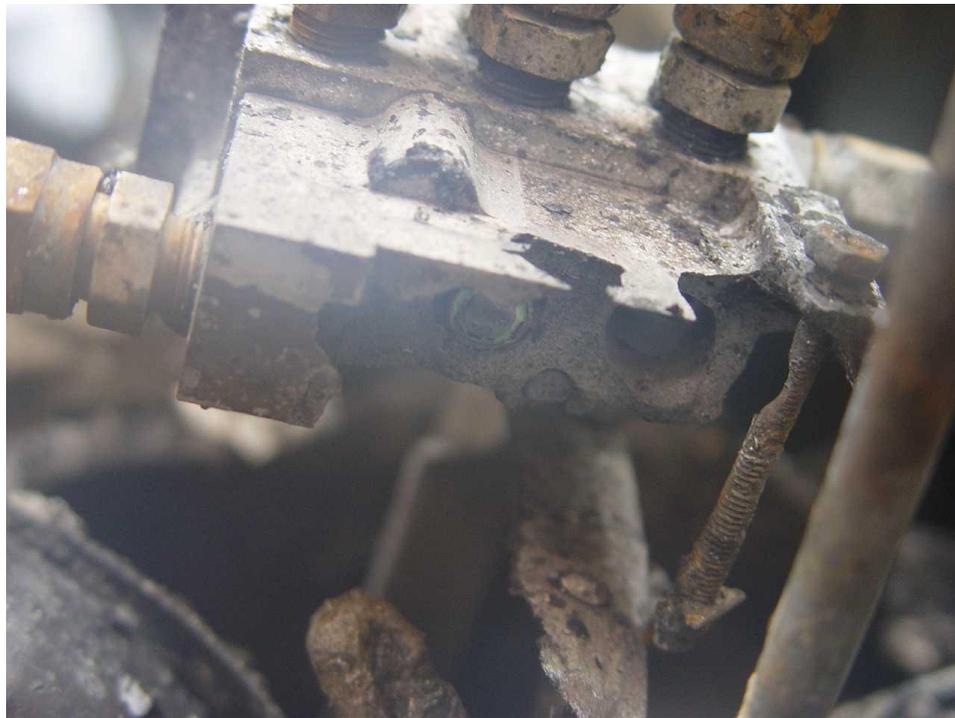
NAS Jacksonville, Florida

*FIG. 7—Damages to the MCV assembly.*

It is apparent that a kindling chain reaction did occur in the flight station oxygen system since the inlet manifold of the MCV assembly was burned out. The physical evidence is consistent with a fire starting in the seat of check valve 3 (probably by flow friction, or in check valve 2 or 3, possibly by particle impact). This fire propagated to the aluminum poppet or the stainless steel retainer screw to the aluminum MCV assembly body. The fire burned through the MCV assembly body, releasing pressurized oxygen and the accompanying burning debris to the cabin. Several torches of flame and debris developed as the oxygen flowed out of the cylinders through the burned breeches in the system.

Because of this dramatic kindling chain and the two fires of similar origin and magnitude that had occurred previously in the RAAF and U.S. Navy, the MCV assembly was recommended to be replaced with one made from a burn-resistant material, such as Monel 400 or Monel K-500. Such a replacement would harden this system against ignition and burn propagation and dramatically reduce the likelihood of a catastrophic fire occurring. This recommendation, which was also made after the analyses of the previous fires, has been implemented. The entire U.S. and Canadian fleets of P-3 aircraft have been retrofitted with Monel-bodied MCV assemblies with an upgraded design and more burn-resistant materials.

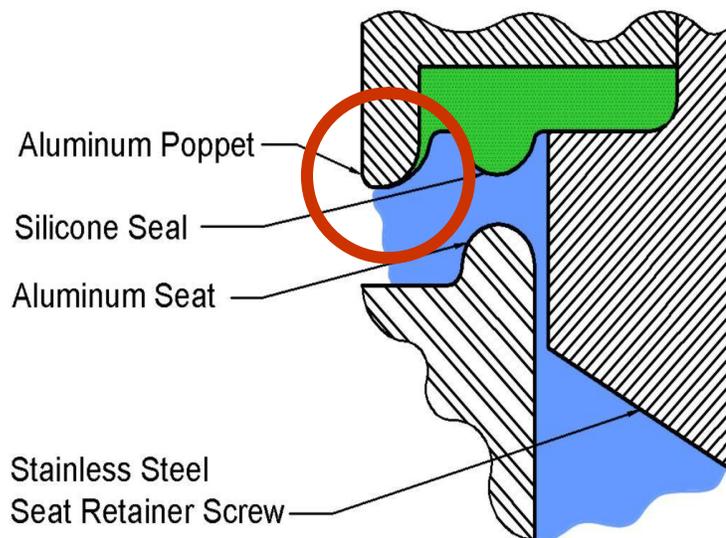
In this case, the pressure drop from the center manifold to the inlet manifold was as high as 1 900 psi (13 000 kPa) due to leakage in the inlet line. A small leak from the center manifold to the inlet manifold across the silicone seat of check valve 3 was probable. Flight line technicians reported such leaks are common and often measures are taken to stop such leaks. This was explicitly the case in the U.S. Navy VQ-11 fire incident previously mentioned. It was surmised that a similar leak existed in this check valve as well. The silicone seat material in the MCV assembly check valves has a relatively low ignition temperature, 504 °F (262 °C). Additionally, a “ribbon” of silicone material exists at the outer diameter of the molded silicone seal that could produce heat if vibrated by the flow and constrained by the poppet and seat. Fig. 8 provides an illustration of an open MCV assembly check valve and indicates where a “ribbon” of silicone material may be developed. Therefore, ignition by flow friction was concluded to be highly probable.

FIG. 8—Cross-sectional view of an MCV assembly check valve seat. The encircled area indicates the location where a “ribbon” of silicone material may be developed.

- 2) Leak of “weeping” flow across external or internal seals: Fig. 8 illustrates the check valve seals are configured so a delaminated ribbon of silicone can easily be formed and oxygen could flow between this delaminated ribbon and the poppet body.
- 3) Exposed nonmetal in the flow path: The silicone seal material is exposed to the leaking oxygen.

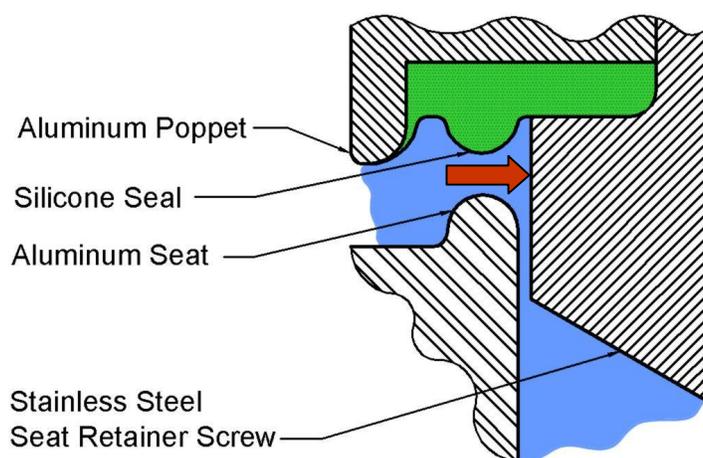
In this case, all the characteristic elements could have existed in this component. That particles existed in the component was indicated by examination of exemplar units, which contained particulate contamination. The pressure drop across a possibly leaking seat from the center manifold to the inlet manifold would generate a high gas velocity. A high-velocity particle could have impacted the stainless steel seat retainer screw as shown in Fig. 9. The stainless steel screw is flammable at 1 900 psig (13 000 kPa) and the particle was assumed to have been flammable. Ignition by particle impact was concluded to be possible.

FIG. 9—Cross-sectional view of the MCV assembly check valve poppet. The arrow indicates a possible particle impact location.

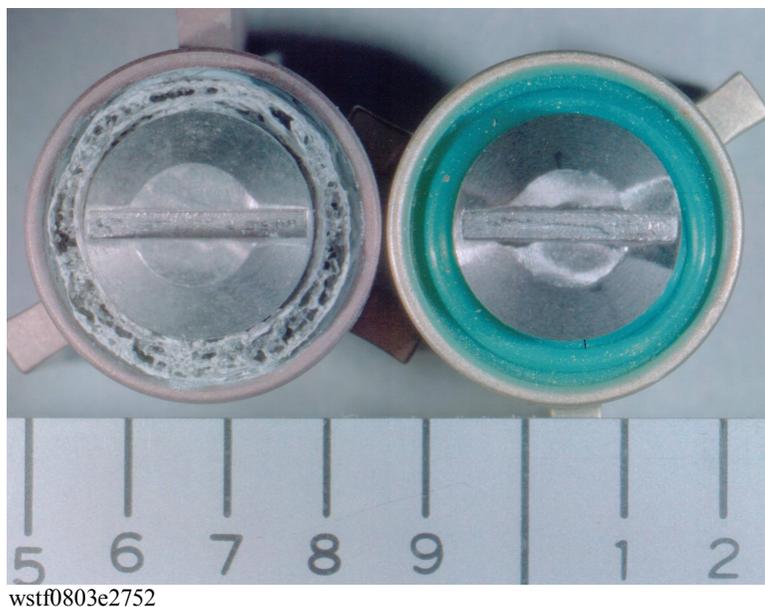
During the performance of the failure analysis on the VP-62 flight station oxygen system fire, WSTF personnel received twelve check valve poppets from NAS Jacksonville personnel. Eleven of the twelve poppets were damaged. Fig. 10 shows a typical damaged poppet and an undamaged poppet.

FIG. 10—A typical damaged MCV assembly check valve poppet (left) and an unused, undamaged poppet (right) as shown with a scale in inches.

- 1) Particles in the flowing oxygen: These check valves were contaminated. See the contamination in Fig. 10 and Fig. 12.
- 2) High gas velocity: If a leak was occurring across the silicone seal into a low-pressure inlet manifold, sonic velocity could occur.
- 3) Impact point and residence time: Particles could impact on the side of the stainless steel seat retainer screw and reside there momentarily (Fig. 9).
- 4) Flammable particle and target: The stainless steel screw is flammable.

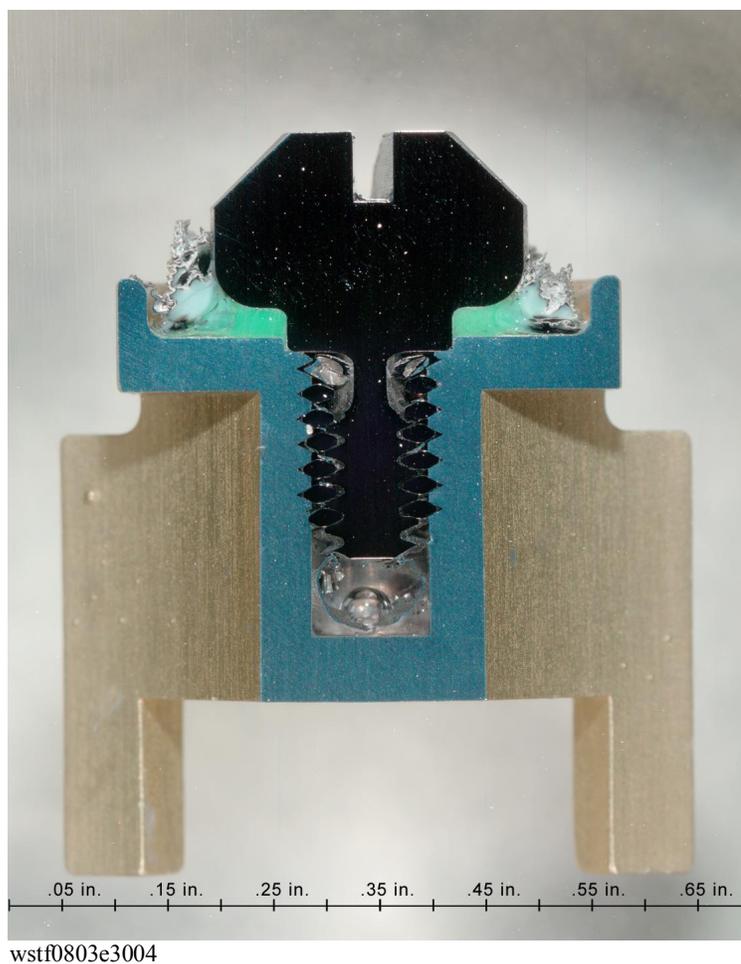
A cross-sectional view of one of the eleven damaged poppets is shown in Fig. 11. It can be seen that the green silicone seal is damaged. Further observation revealed the silicone seal had been, in fact, partially burned. However, the fire damage did not propagate to consume the entire silicone seal nor did it propagate to the aluminum alloy check valve poppet or the stainless steel seat retaining screw.

FIG. 11—Cross-sectional view of a burn-damaged MCV assembly check valve poppet.

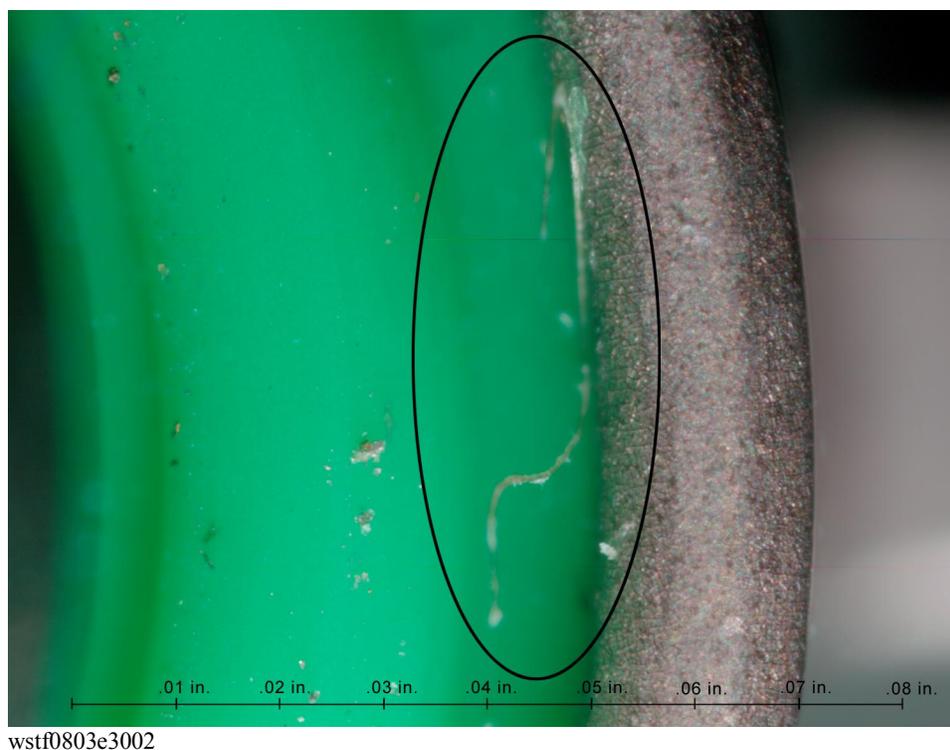
As was previously mentioned, recent experiments at WSTF indicate pressurized gas flowing past a ribbon of elastomeric material can cause a vibration of the material. If, in another location near the leak, the vibrating material is partially constrained from moving it will be heated at the point that the constraining part touches the elastomer. In preliminary experiments using 30 psig (310 kPa) air flowing past a ribbon of silicone material, heat damage to the silicone material was observed. This scenario is present in the MCV assembly check valve seal. Fig. 12 shows a close-up view of a delaminated fiber of silicone seal material that may have been damaged by heat from this postulated ignition mechanism.

Flow friction heating was considered a highly probable cause of the fire damages observed in the eleven MCV assembly seals.

FIG. 12—*Close-up view of delaminate fiber of silicone seal material showing possible heat damage due to postulated flow friction heating.*

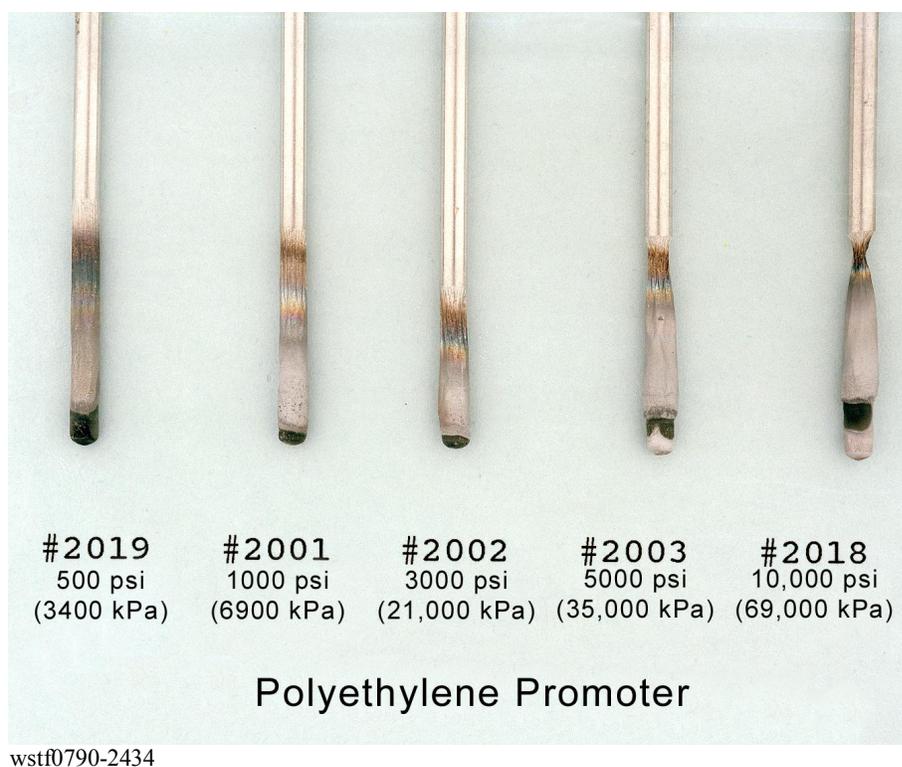
The anodized layer on the aluminum poppet body was surmised to have protected it from burning. The literature data indicate aluminum oxide is a coherent protective oxide that must be breached before ignition of the metallic aluminum substrate material can occur [10]. An anodized layer has been found to provide additional protection against the ignition of aluminum even beyond that provided by the naturally occurring oxide [11]. In addition, tests have been performed at WSTF in which high-density polyethylene ignition promoters were pressed over the ends of aluminum rods and ignited in oxygen at up to 10 000 psi (69 000 kPa). The rods were suspended vertically from the top and the polyethylene promoters were located at the bottom end of the rods. In most cases, see Fig. 13 for an example of five rods, the aluminum rod melted and deformed but did not ignite.

Analysis confirmed the aluminum oxide film, even though it was obviously thermally softened and deformed, provided an ignition-inhibiting barrier between the aluminum and the oxygen. This protective oxide film of both naturally occurring and chemically applied oxides is thought to be what prohibited the propagation of the fire in the eleven MCV assembly check valve poppets.

FIG. 13—Aluminum rods that did not ignite when exposed to burning polyethylene at various oxygen pressures.
